GEOLABS, INC.

February 1, 2012
W.O. 6598-00

**GEOTECHNICAL ENGINEERING SERVICES
DUE DILIGENCE STUDY
OFFICE OF HAWAIIAN AFFAIRS (OHA)
SETTLEMENT PARCELS
KAKA'AKO, OAHU, HAWAII**

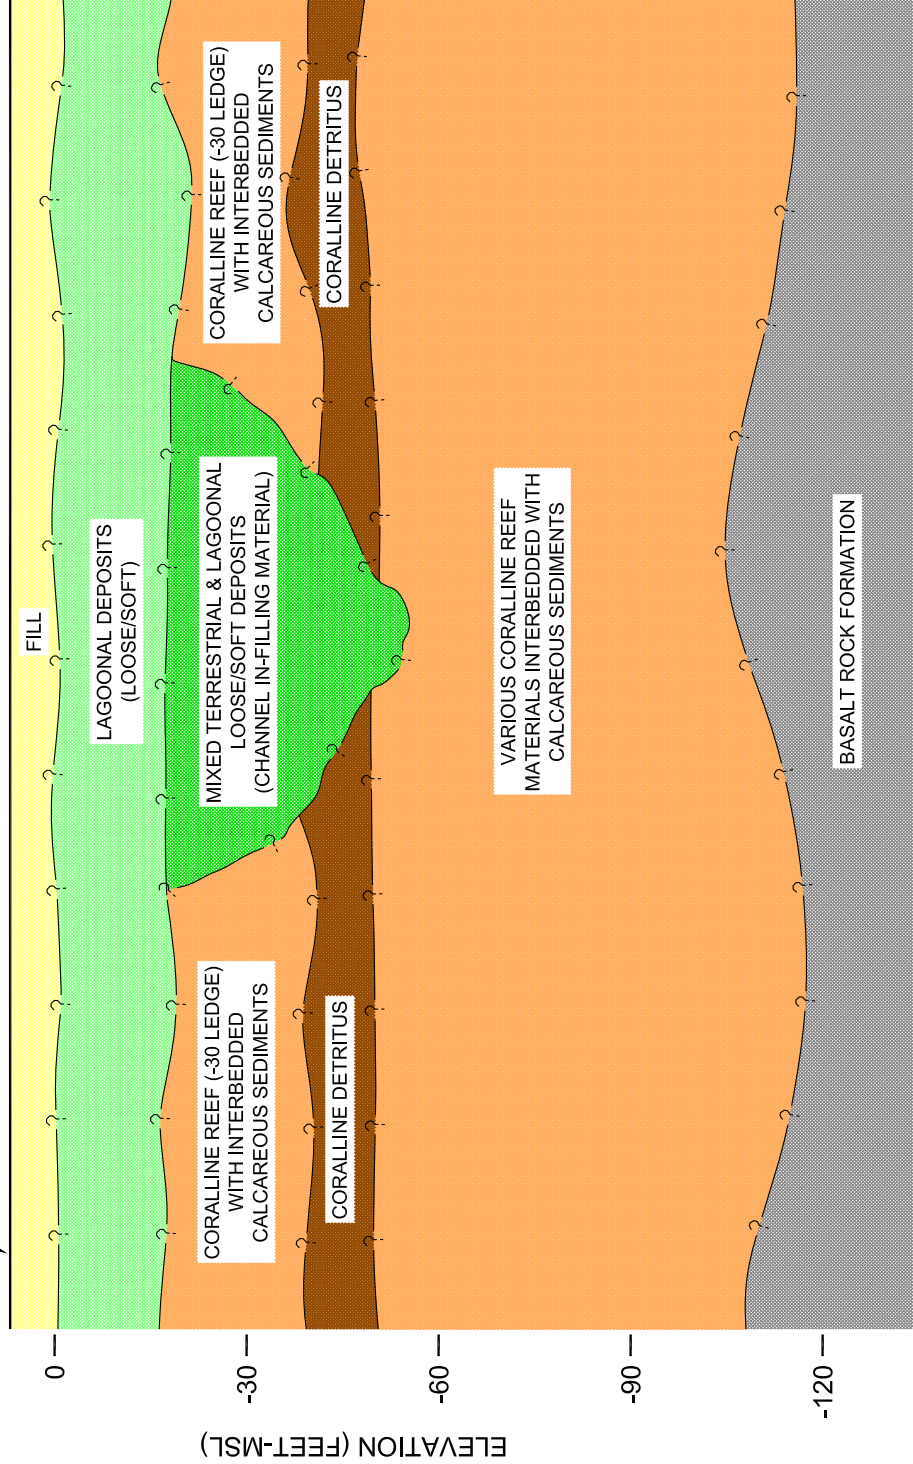
IDEALIZED SUBSURFACE PROFILE A-A'

We anticipate that the subsurface conditions below the lagoonal deposits and the bottom of the alluvial channel would consist of interbedded layers of coral formation, coralline detritus, and alluvium extending to depths of about 110 to 125 feet below the existing ground surface. Basalt formation is anticipated at depths of about 110 to 125 feet below the existing ground surface. However, our research indicates that the basalt formation could extend to as deep as about 150 feet below the existing ground surface. An idealized subsurface profile is shown on Plate 3.

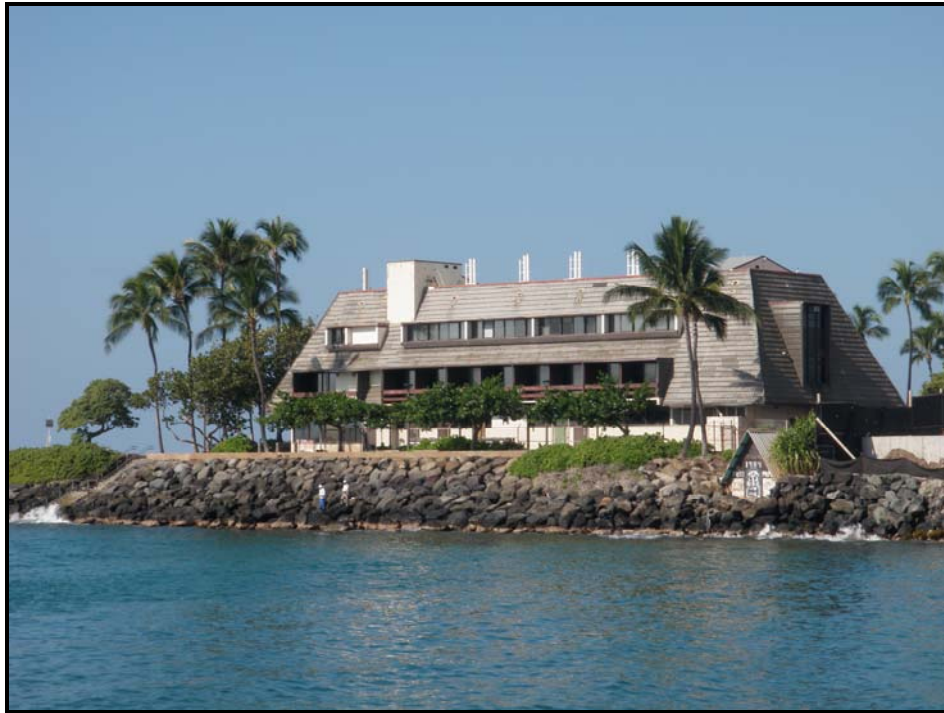
Parcel K (TMK: 2-1-060: 001) is at the south end of Ahui Street. The parcel is bounded by Kaka'ako Waterfront Park parking lot to the west, Kewalo Basin to the east, and Kaka'ako Waterfront to the south. Based on our observations, the site is relatively level. A rock revetment is present along the east and south sides of Parcel K. The rock revetment appears to be in relatively good condition. A public walkway was observed between the rock revetment and Parcel K.

Photograph No. 1: Rock revetment in good condition along Kewalo Basin side of Parcel K.

Periodic inspection and maintenance of the existing waterfront structures should be implemented. In addition, further engineering analyses should be conducted when new buildings are planned adjacent to existing bulkheads. The existing bulkheads may not support the additional surcharge stresses, which would require new bulkheads to be constructed as part of the shoreline parcel redevelopment. The text of this report should be referred to for detailed discussion and generalized geotechnical evaluation of the site with respect to the proposed project.

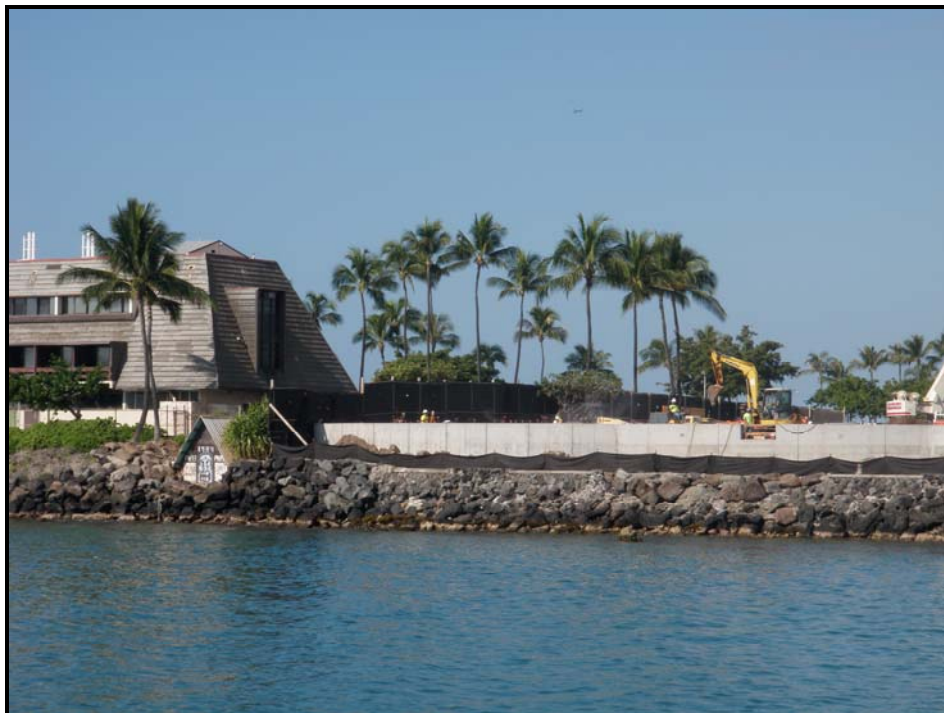
A rock revetment is present along the Kewalo Basin side of Parcel D. Based on our observations, the rock revetment consists of basaltic boulders and cobbles. The voids within the upper half of the rock revetment have been filled with grout/concrete.

Photograph No. 2: Rock revetment in fair to good condition along Kewalo Basin side of Parcel D.

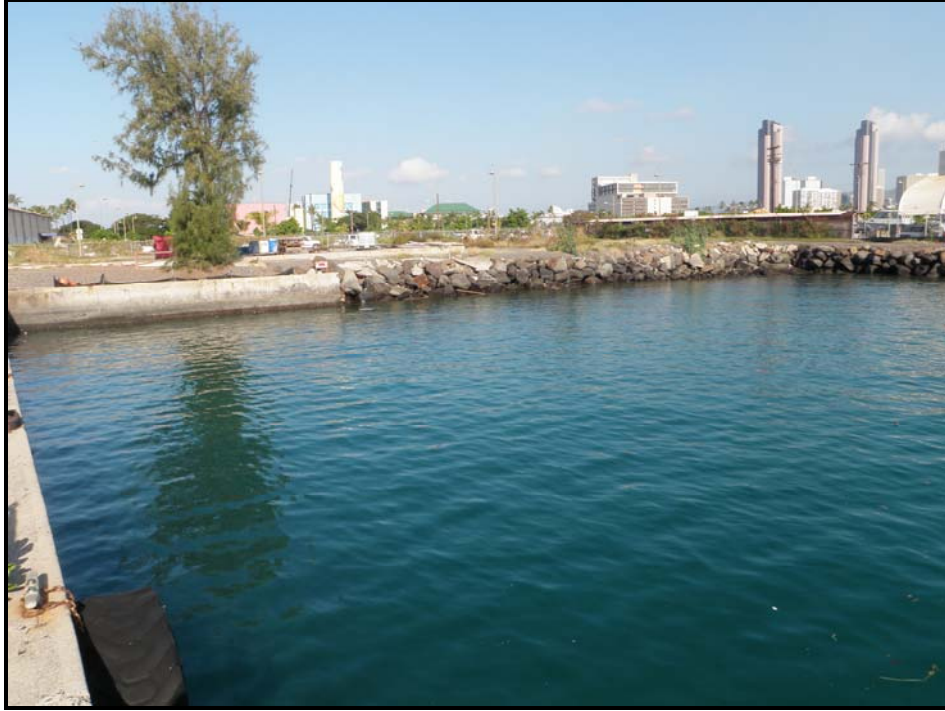
A rock revetment and concrete bulkhead wall were observed above the water level. The rock revetment consists of basaltic boulders and cobbles and appears to be in relatively poor condition. Based on our observations at the north end of the concrete wall, a steel sheet pile wall may be present below the concrete wall. The exposed steel sheet pile appears to be highly corroded. The fill material behind the concrete/sheet pile wall consists of large boulders, cobbles, gravel, and sand. Portion of the backfill behind the north end of the concrete/sheet pile wall appears to have been eroded away possibly from constant tidal fluctuation and wave action.

We also observed some small surface voids near the rock revetment. We believe that the surface voids may be a result of the fill materials migrating into the voids of the rock revetment.

Photograph No. 3: Rock revetment in poor condition and bulkhead along Kewalo Basin side of Parcel C.

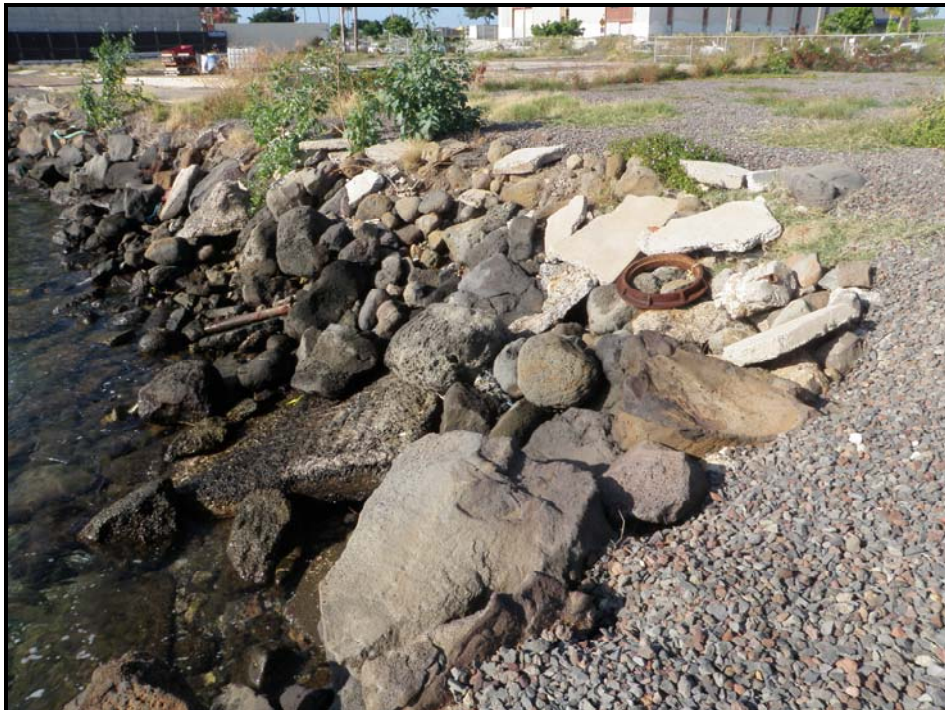
Photograph No. 4: Closer view of rock revetment at Parcel C. Rock revetment consists of boulders, cobbles, and concrete debris.

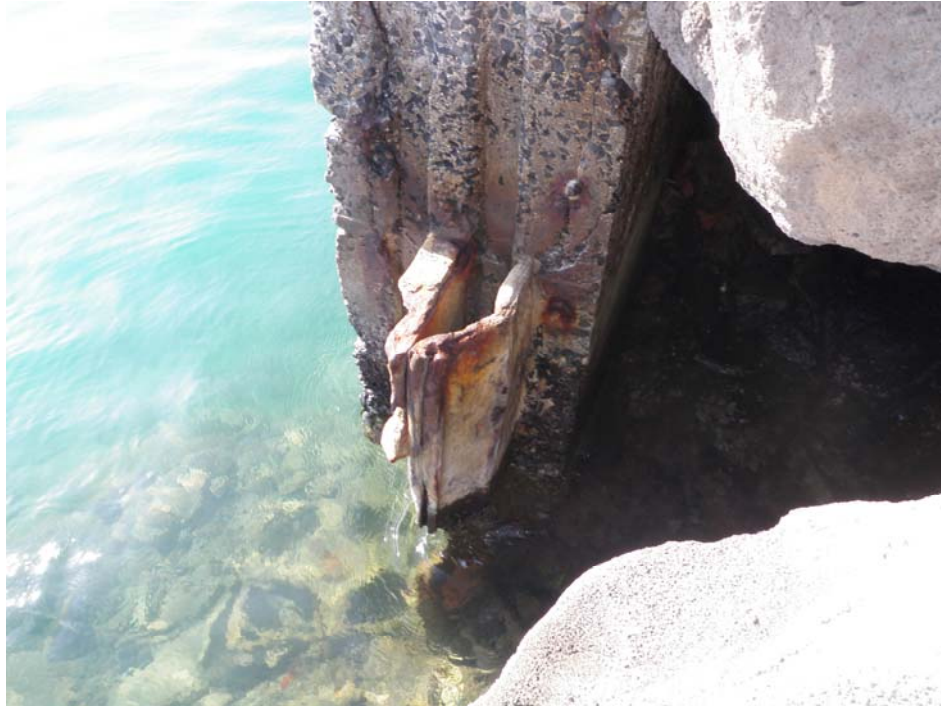
When the steel sheet piles corrode, the structural integrity of the wall could be affected. The retained backfill could also migrate through the corroded areas of the steel sheet pile resulting in voids behind the bulkhead. The voids may collapse over time causing ground settlement adjacent to the bulkhead.

Photograph No. 5: Corrosion of sheet pile and erosion of backfill material behind bulkhead at Parcel C.

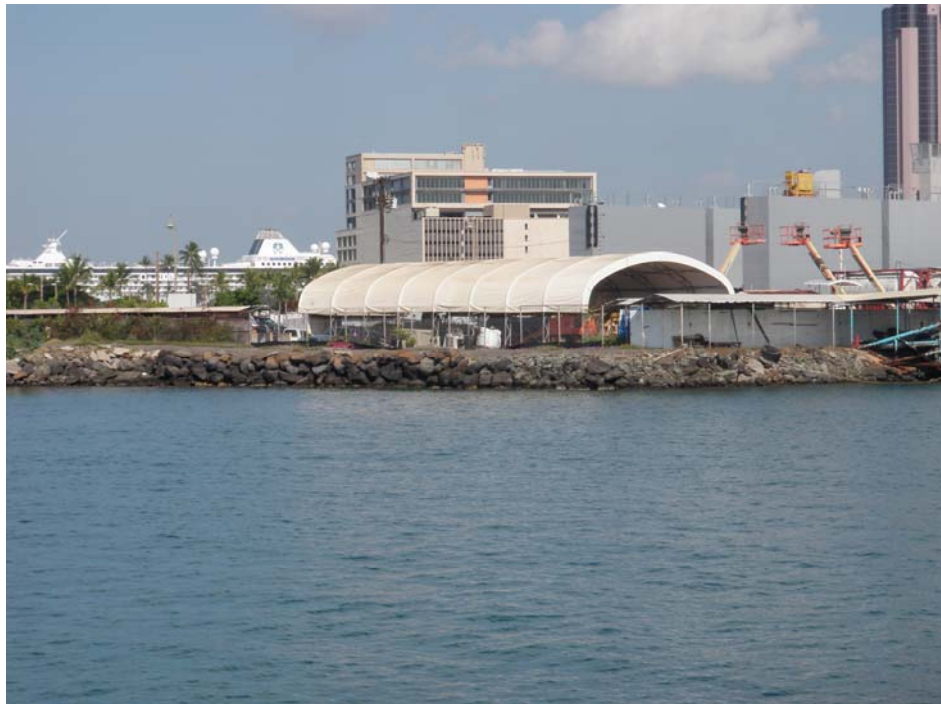
Parcel B (TMK: 2-1-058: 002 and 035) is bounded by Ahui Street on the west, and Kewalo Basin on the east. An existing warehouse and dry dock structures were observed at the site. A rock revetment and concrete bulkhead wall were observed above the water level along the Kewalo Basin side of the parcel. The rock revetment consists of basaltic boulders and cobbles. Based on our observations, the rock revetment appears to be in poor condition.

We also observed some small surface voids near the rock revetment. We believe that the surface voids may be a result of the fill materials migrating into the voids of the rock revetment.

Photograph No. 6: Rock revetment in poor condition along Kewalo Basin side of Parcel B.
