Attachment 3: Pictures

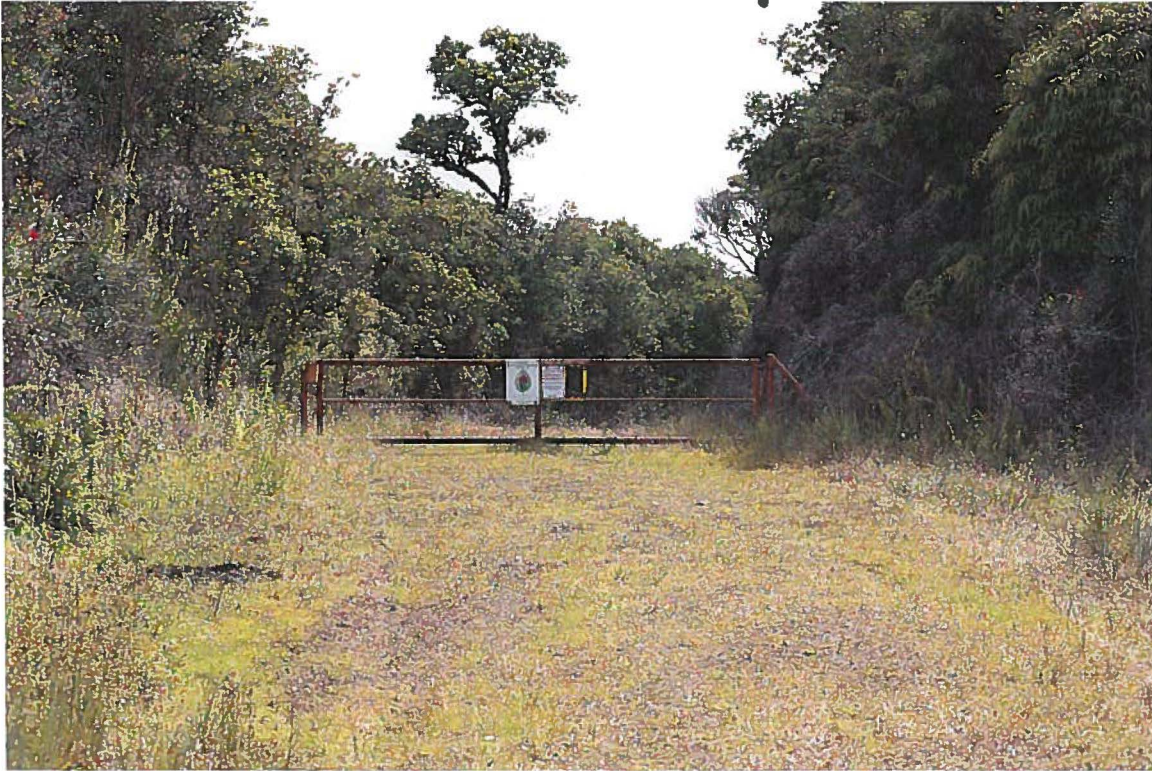
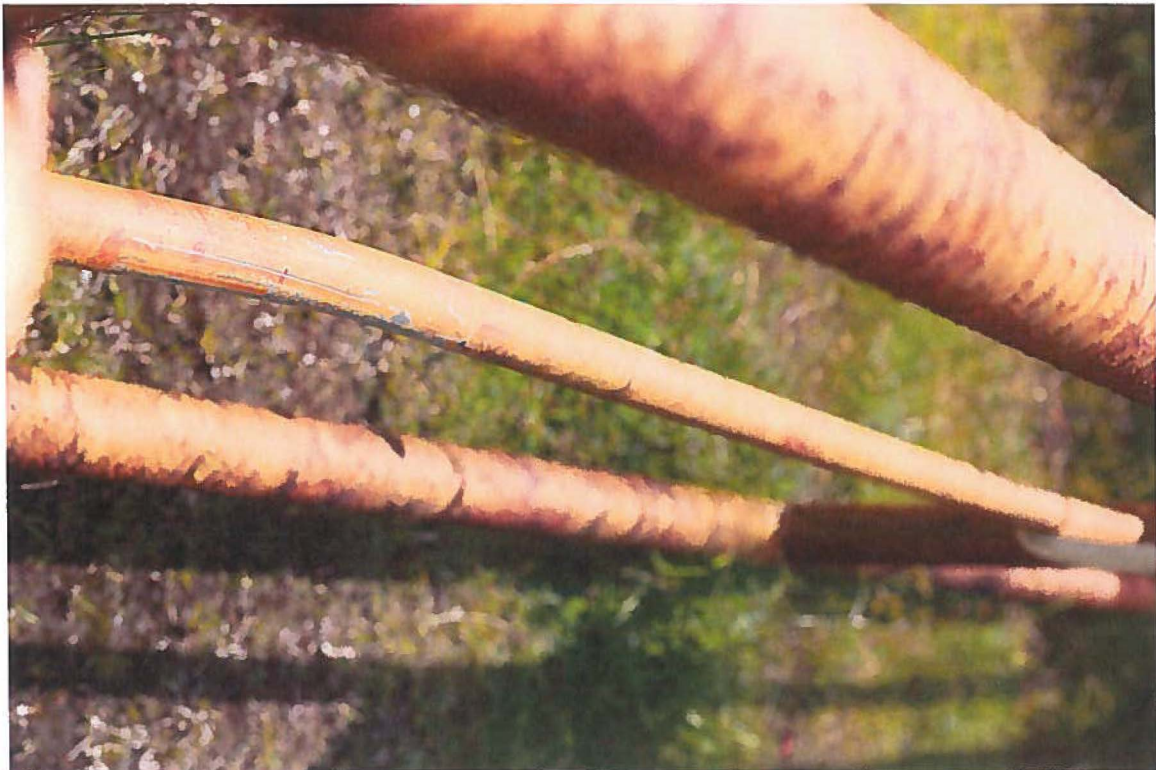
View of gate from afar

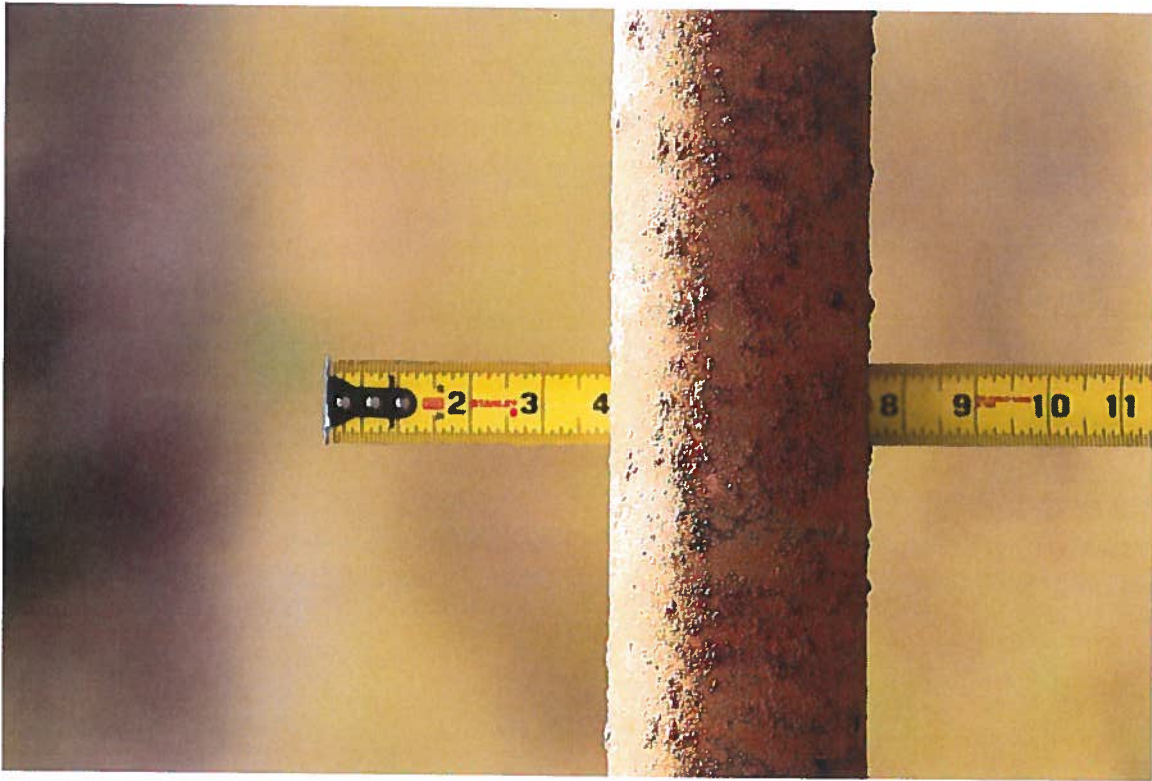
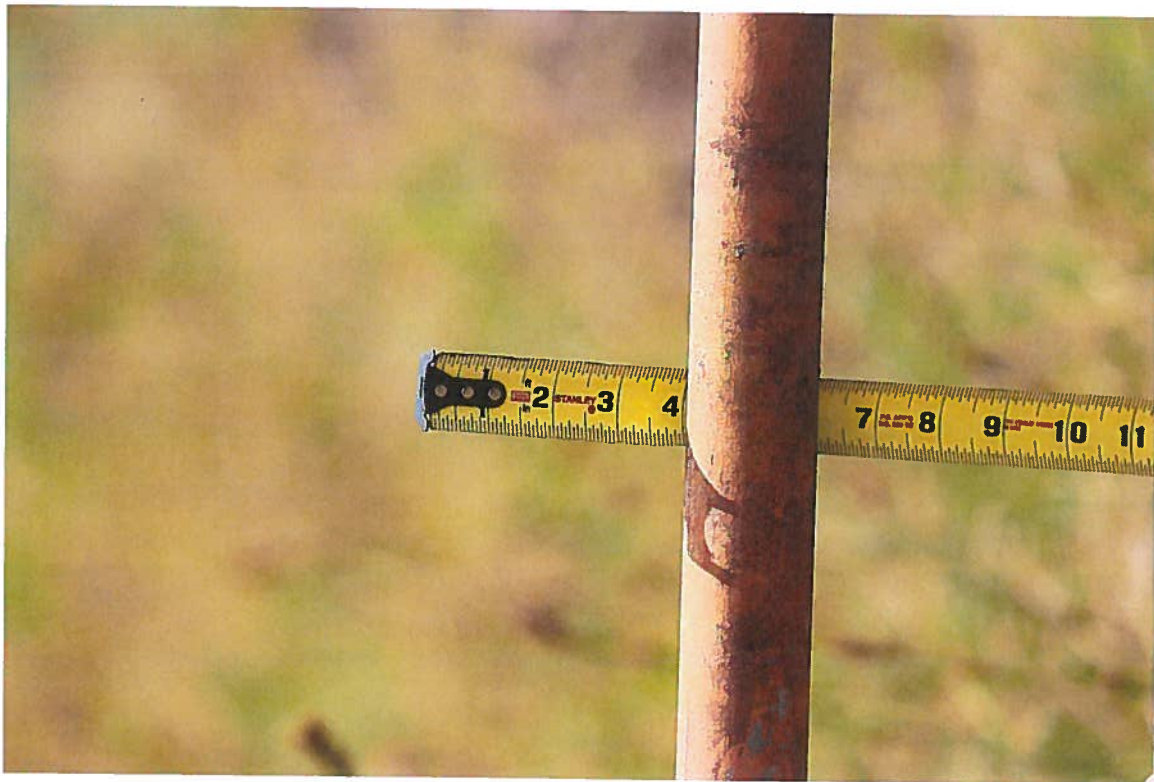
Close up of bent pipe

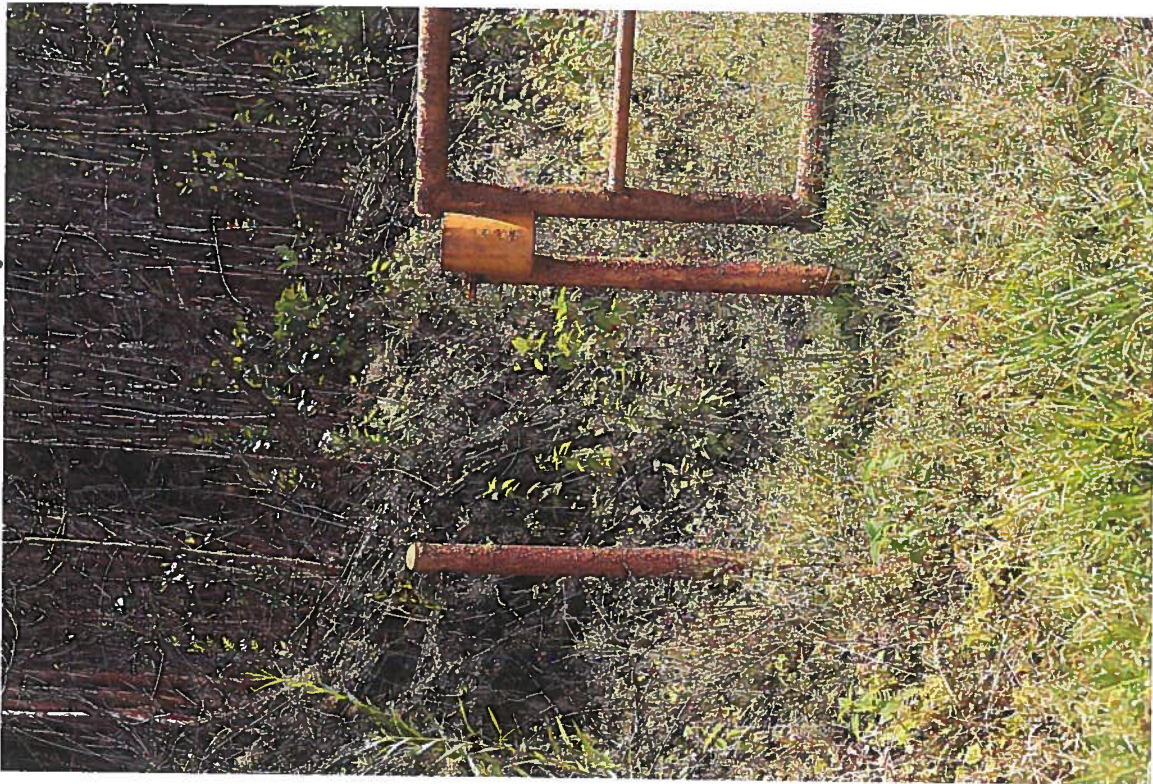
Left side of lock protector

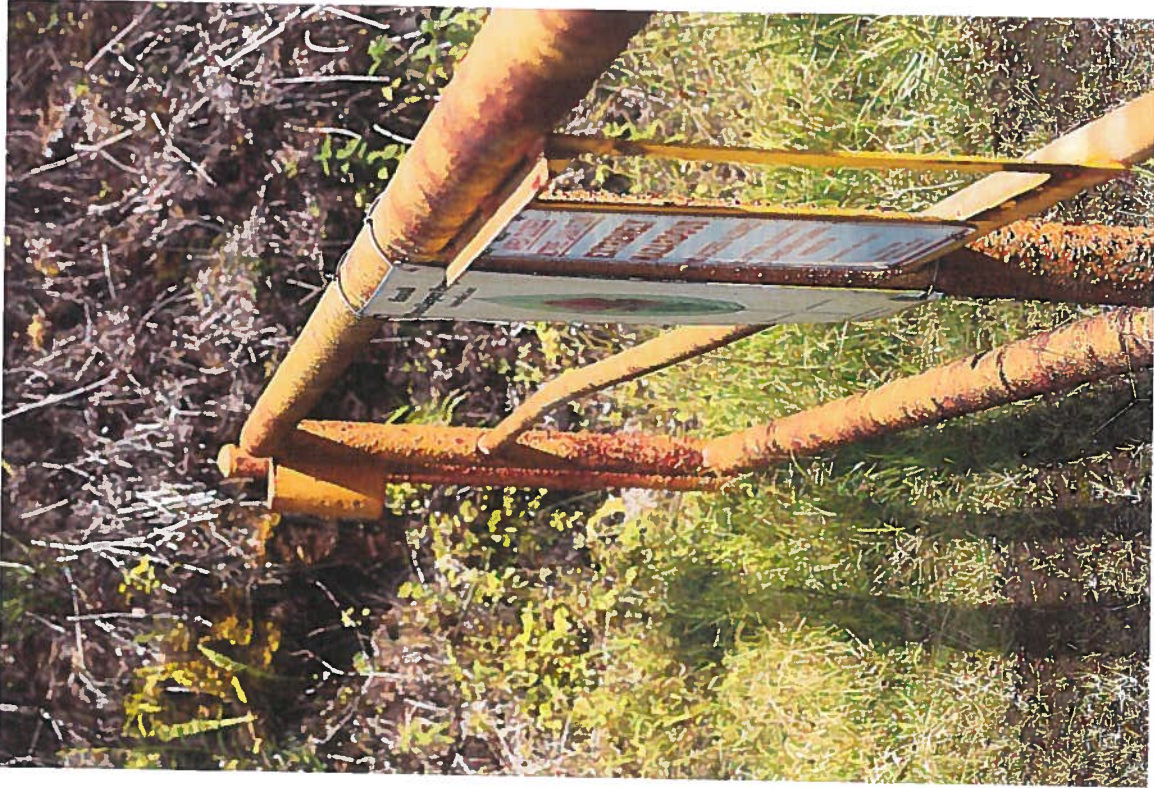
Middle pipe to be repaired

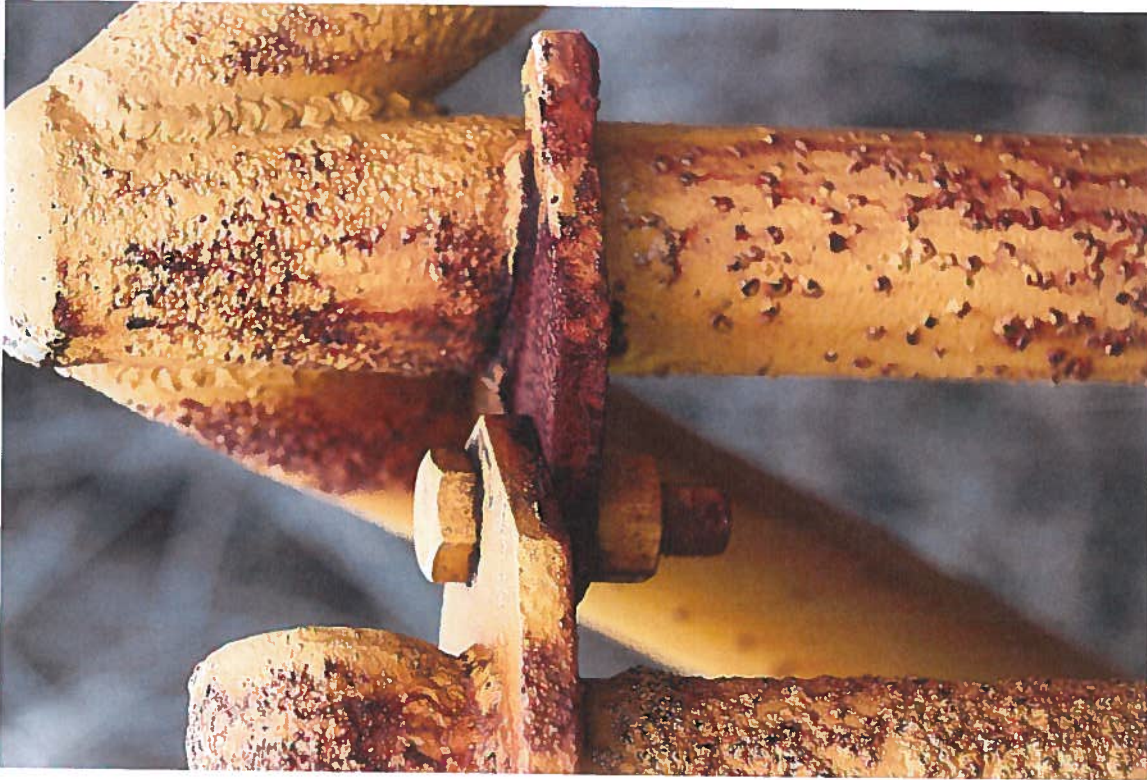
Right Side of gate close up

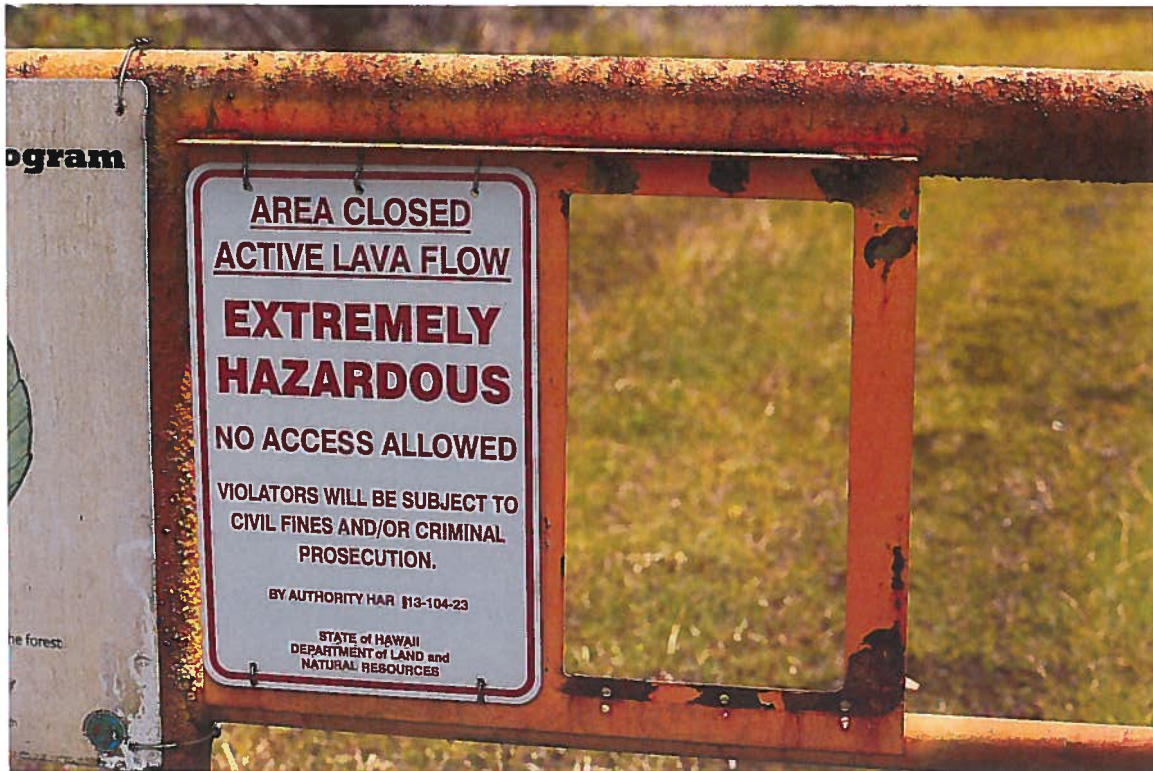
Rust around sign

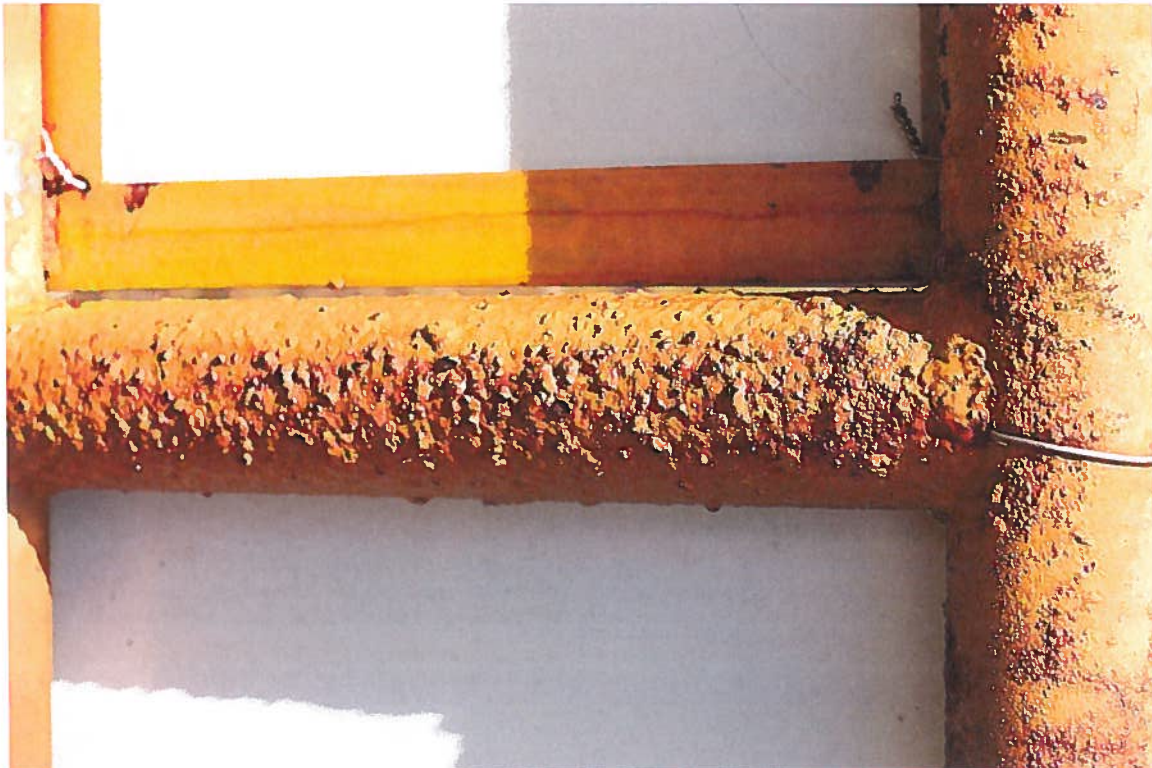
Rust back of sign

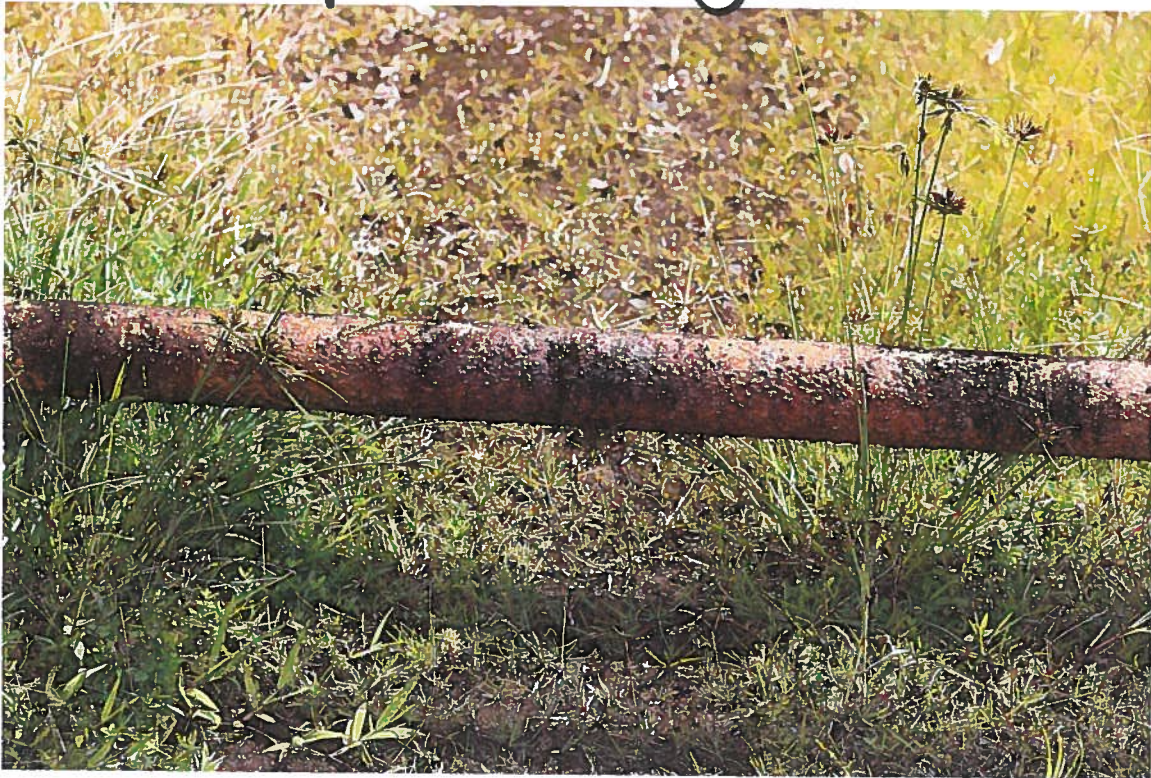
Bottom portion of gate
