Phase I Environmental Site Assessment

The Galbraith Estate Property
Wahiawa, Oahu, Hawaii

December 6, 2012
Project No. 17012-012185.00

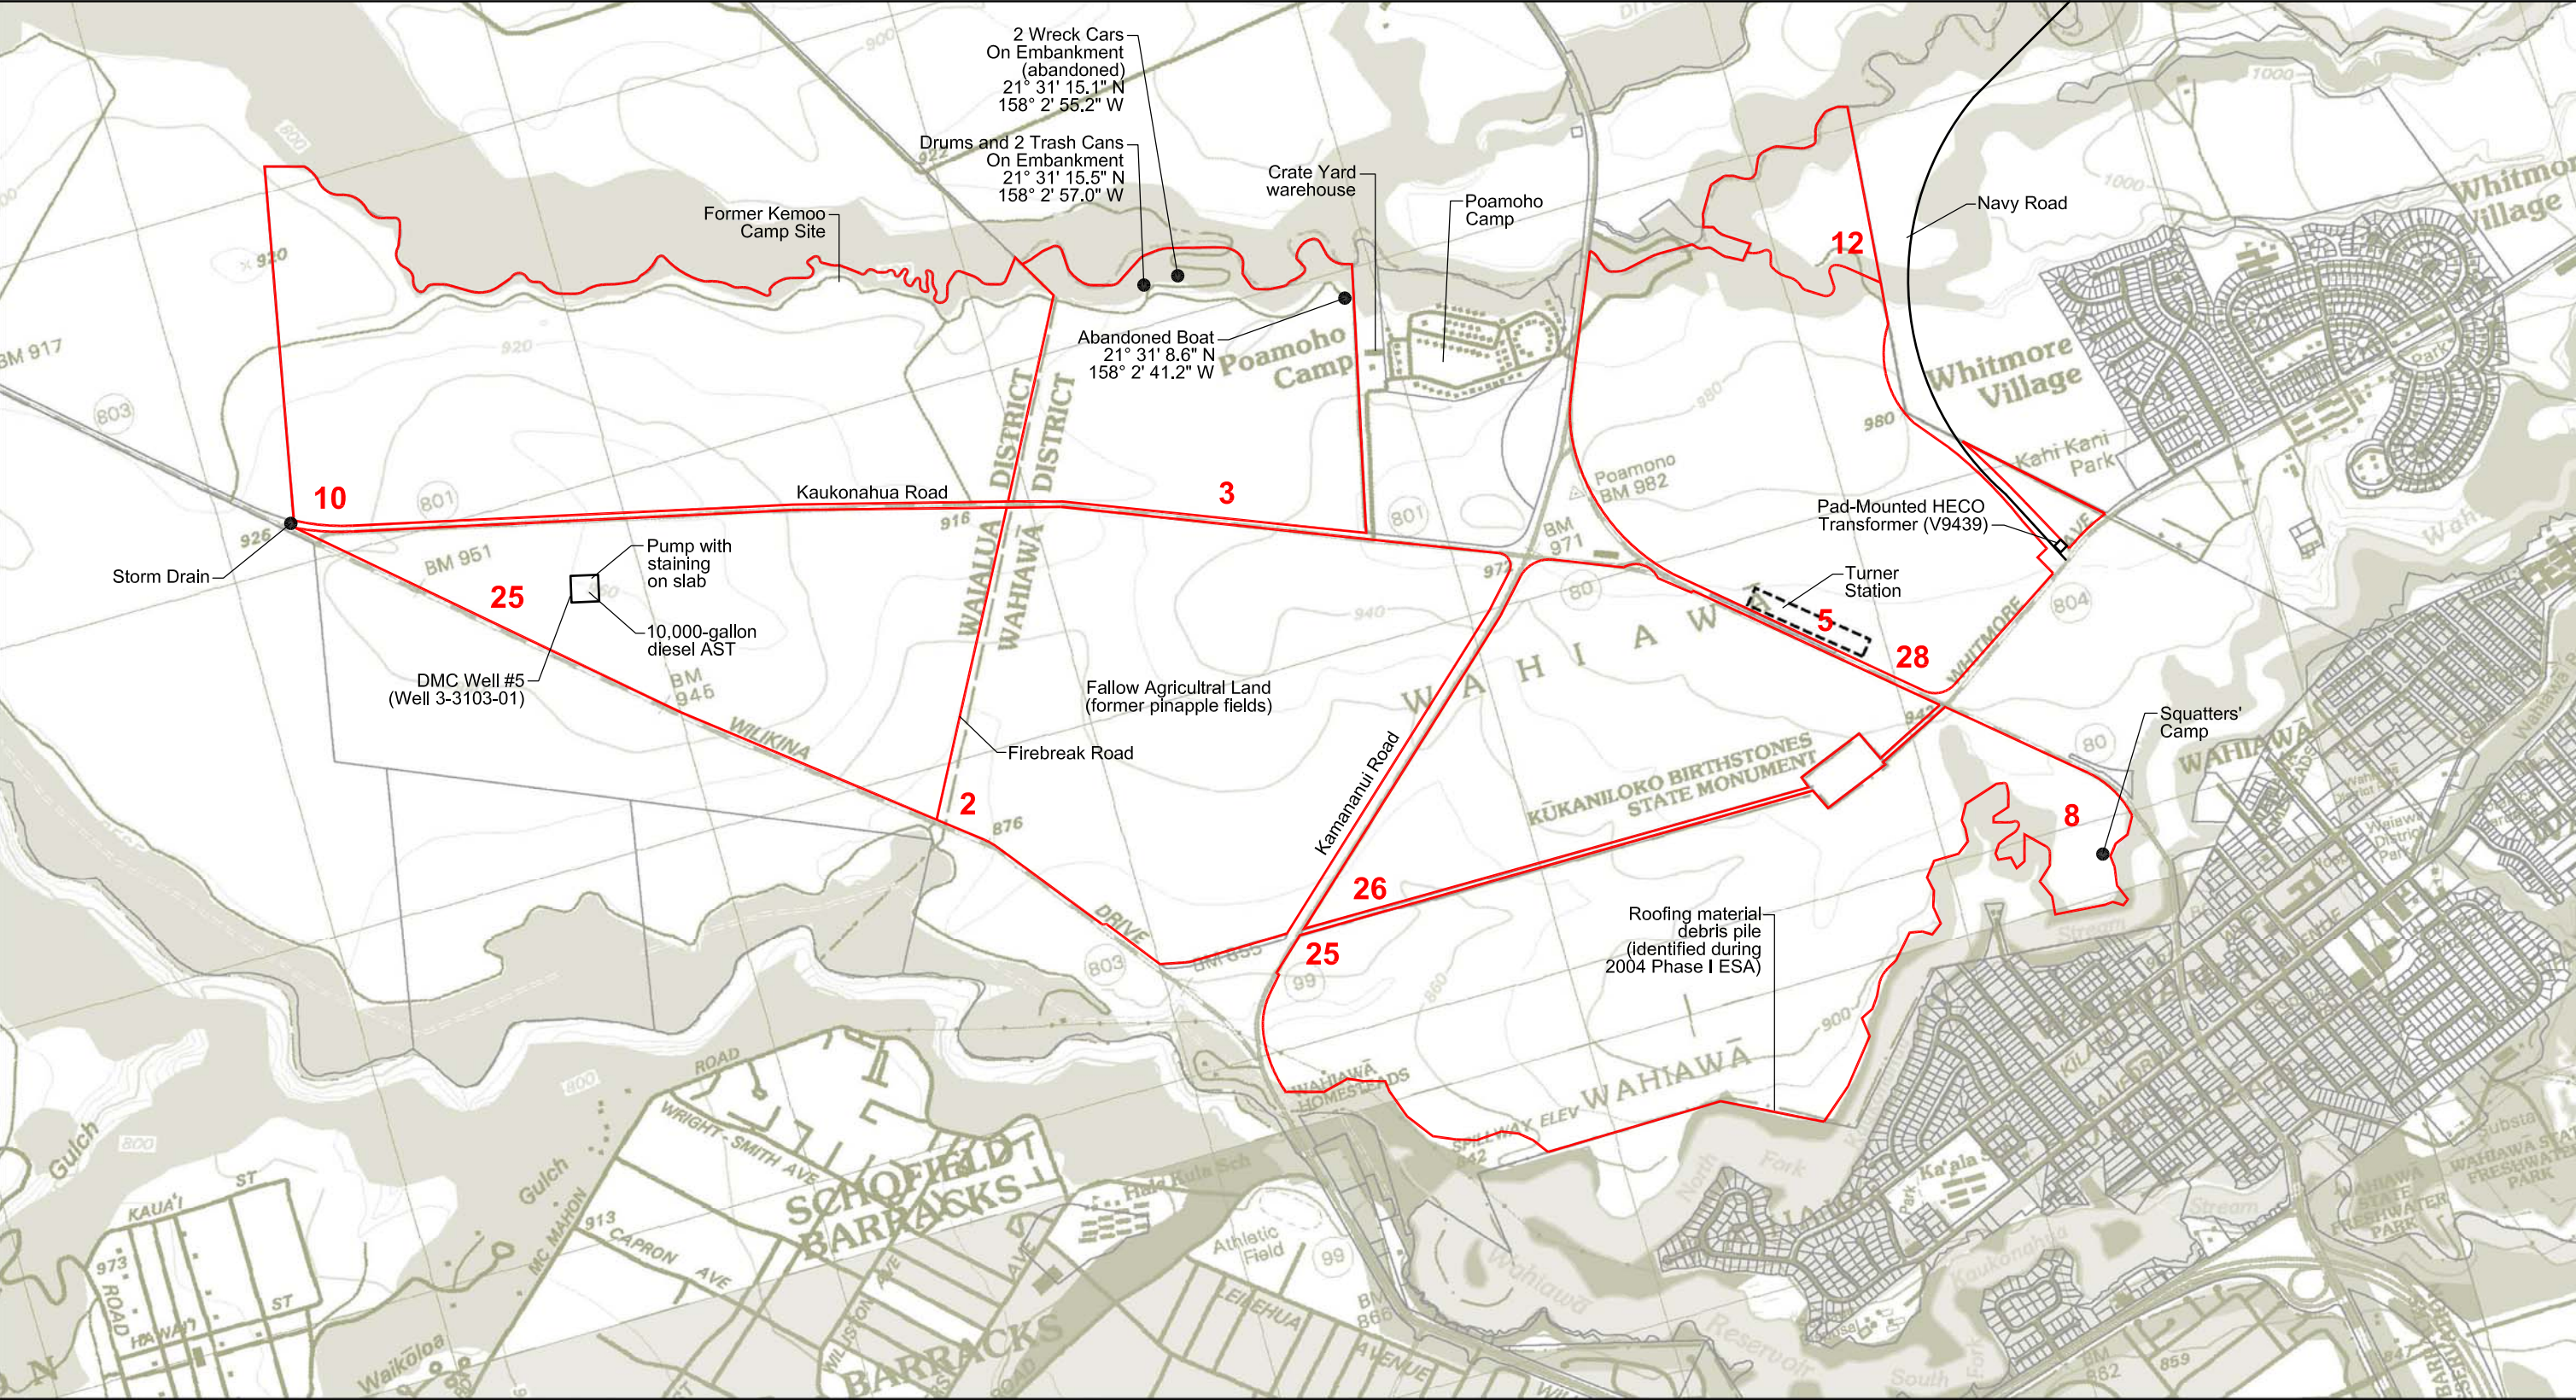
Project No.: 17012-012185.00	Site Vicinity Map	FIGURE 2
		Date: 11/02/12		
		Revised By: DG	Trust for Public Land	
		Checked By: TS

The area surrounding the subject property is a mixture of commercial, agricultural, and residential land. Adjoining properties were observed (from the subject property or from public access areas) for signs of recognized environmental conditions and their potential to pose an environmental concern to the subject property (Figure 2, *Figures* tab). The uses and features of adjoining properties are described below.

No staining or other evidence of releases was observed around the abandoned items and other waste. The areas of unauthorized dumping and trash are shown in Figure 2, behind the *Figures* tab.

This finding is not considered a *REC* because there is no evidence of significant releases from the abandoned vehicles and other waste items. However, because these items are a nuisance attraction, Bureau Veritas recommends that they be removed and properly disposed. The ground beneath these items should then be assessed for staining or other evidence of releases.

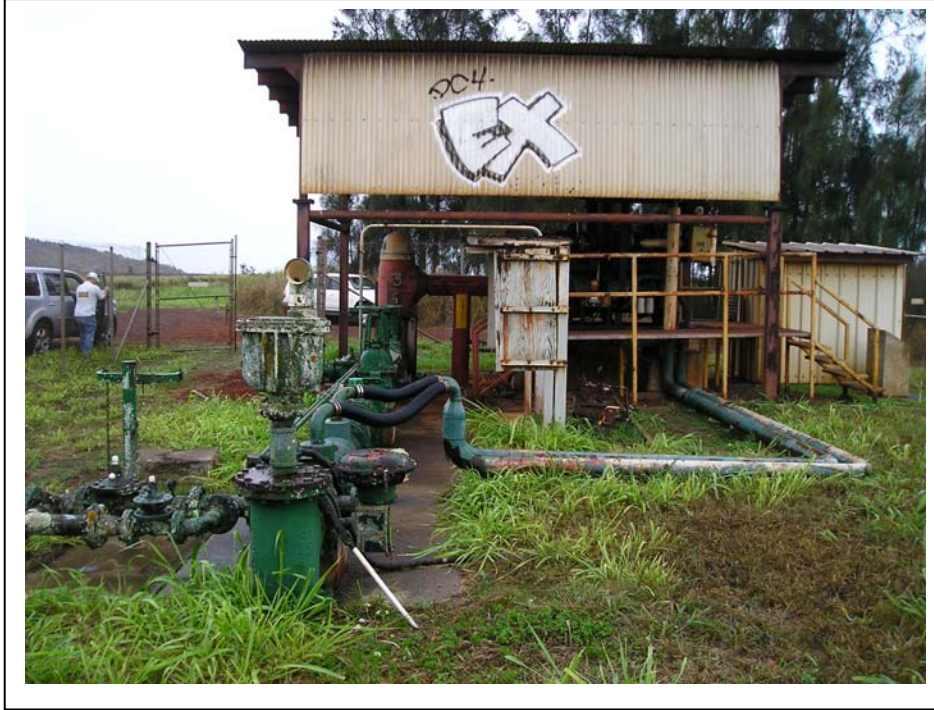
Project No. 17012-012185.00	Description	Well pump motor at DMC Well #5 (aka Del Monte Pump 5) / Bott Well (Well 3-3103-01) site, showing wellhead in foreground, looking west	Photo 1
	Site Name	Galbraith Estate Property, Wahiawa, Oahu, Hawaii	Photo Date October 16, 2012
	Client	Trust for Public Land

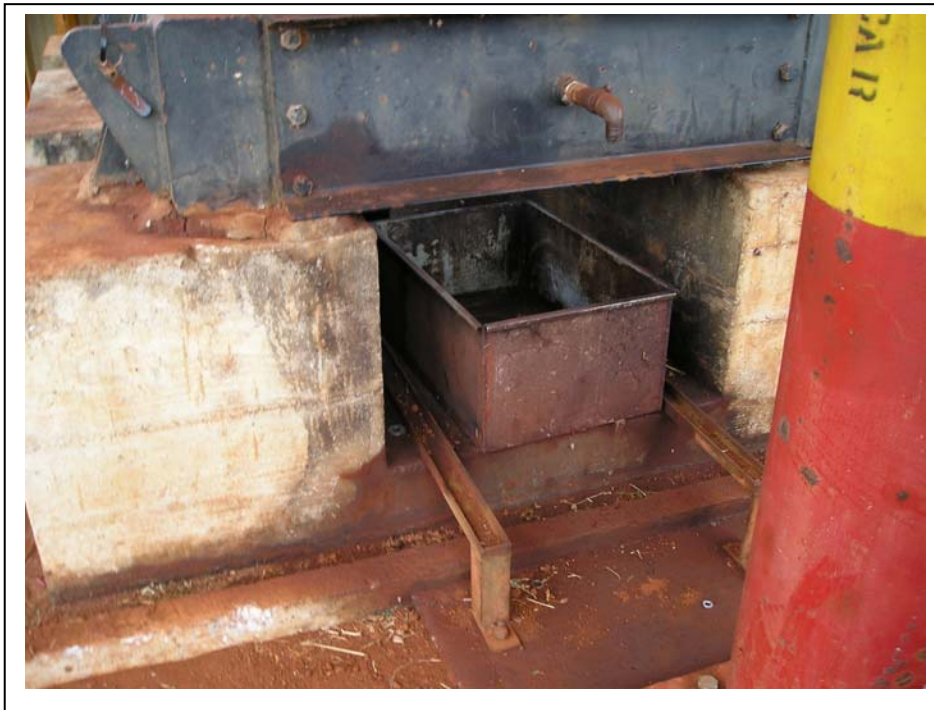
Project No. 17012-012185.00	Description	Formerly stained concrete slab below well pump motor at DMC Well #5/Bott Well site (area of 2012 Phase II assessment by Bureau Veritas)	Photo 2
	Site Name	Galbraith Estate Property, Wahiawa, Oahu, Hawaii	Photo Date October 16, 2012
	Client	Trust for Public Land

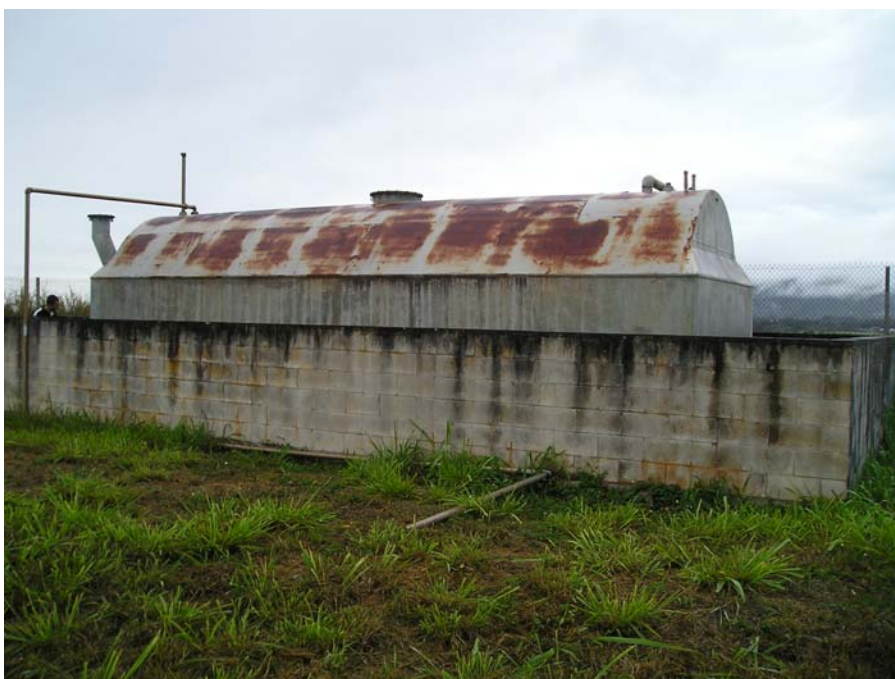
Project No. 17012-012185.00	Description	10,000-gallon diesel AST in secondary containment (no longer in use) at DMC Well #5/Bott Well (Well 3-3103-01) site	Photo 3
	Site Name	Galbraith Estate Property, Wahiawa, Oahu, Hawaii	Photo Date October 16, 2012
	Client	Trust for Public Land

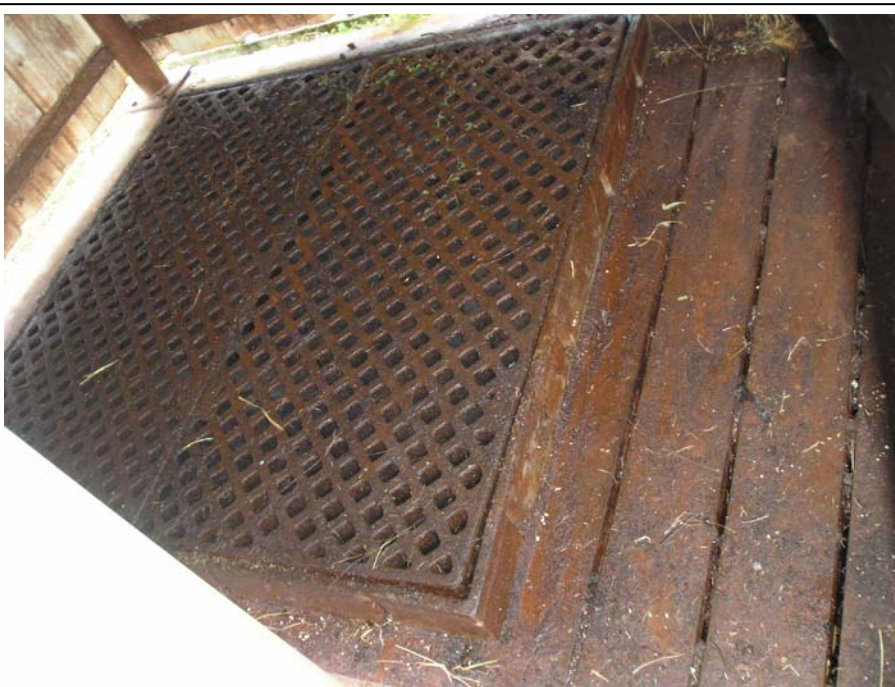
- The DMC Well #5/Bott Well site on the western portion of the subject property includes a small storage shed that formerly contained herbicide and motor oil containers stored on a spill pallet. Staining was observed on the floor of the shed, but no staining was observed on the soil around the shed. Although there is a potential for impacts to the soil around the shed, it is unlikely to be significant because no staining was observed.

Project No. 17012-012185.00	Description	Interior of storage shed at DMC Well #5/Bott Well (Well 3-3103-01) site, formerly used to store herbicide and motor oil containers	Photo 4
	Site Name	Galbraith Estate Property, Wahiawa, Oahu, Hawaii	Photo Date October 16, 2012
	Client	Trust for Public Land

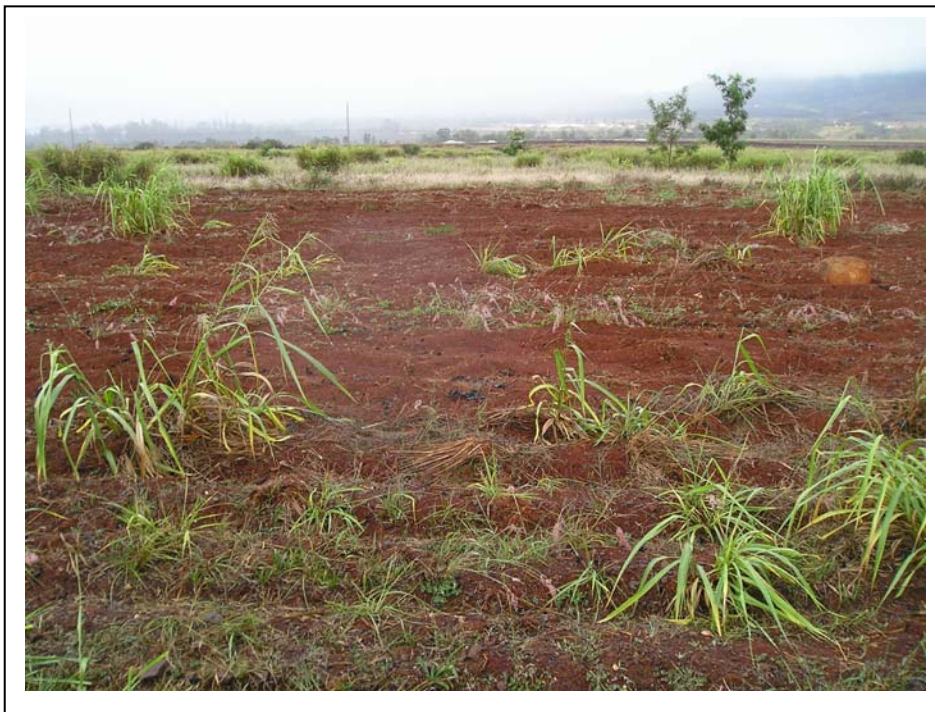
Project No. 17012-012185.00	Description	View of southwestern portion of subject property (Parcel 25), looking southeast from DMC Well #5/Bott Well site	Photo 5
	Site Name	Galbraith Estate Property, Wahiawa, Oahu, Hawaii	Photo Date October 16, 2012
	Client	Trust for Public Land

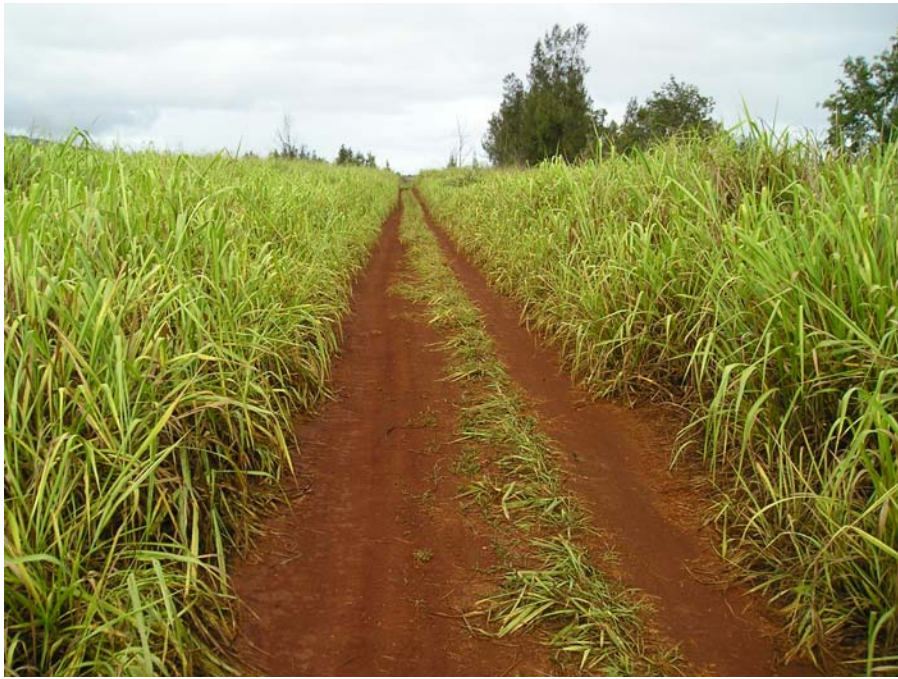
Project No. 17012-012185.00	Description	Unpaved road extending alongside Poamoho Gulch on north-central portion of subject property (Parcel 3), looking west	Photo 15
	Site Name	Galbraith Estate Property, Wahiawa, Oahu, Hawaii	Photo Date October 16, 2012
	Client	Trust for Public Land

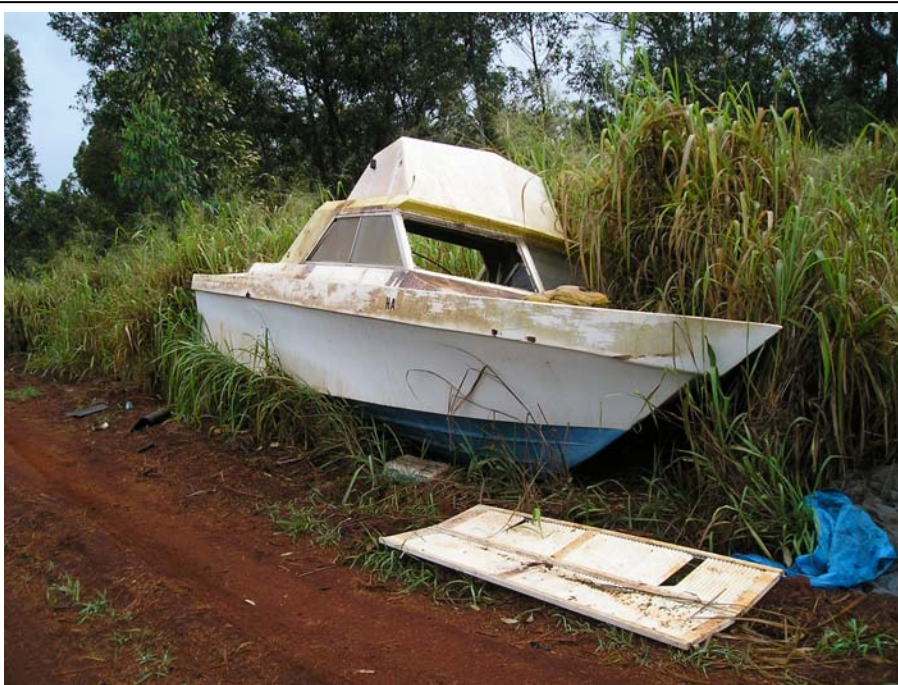
- Abandoned vehicles, vehicle parts, and other waste items were observed on the northern portion of the subject property near or within Poamoho Gulch, including: (1) an abandoned boat (with motor) on the dirt road just west of Poamoho Camp (21 31' 8.6" N/158 2' 41.2" W); (2) two wrecked cars and car parts on the embankment along the winding dirt road that extends down into Poamoho Gulch (21 31' 15.1" N/158 2' 55.2" W); and (3) a rusted 55-gallon drum and two garbage cans on the embankment along the winding dirt road that extends down into Poamoho Gulch (21 31' 15.5" N/158 2' 57.0" W).

Project No. 17012-012185.00	Description	Abandoned boat on dirt road just west of Poamoho Camp (21° 31' 8.6" N/158° 2' 41.2" W), on north-central portion of subject property (Parcel 3)	Photo 16
	Site Name	Galbraith Estate Property, Wahiawa, Oahu, Hawaii	Photo Date October 16, 2012
	Client	Trust for Public Land

This finding is not considered a *REC* because there is no evidence of significant releases from the abandoned vehicles and other waste items. However, because these items are a nuisance attraction, Bureau Veritas recommends that they be removed and properly disposed. The ground beneath these items should then be assessed for staining or other evidence of releases.

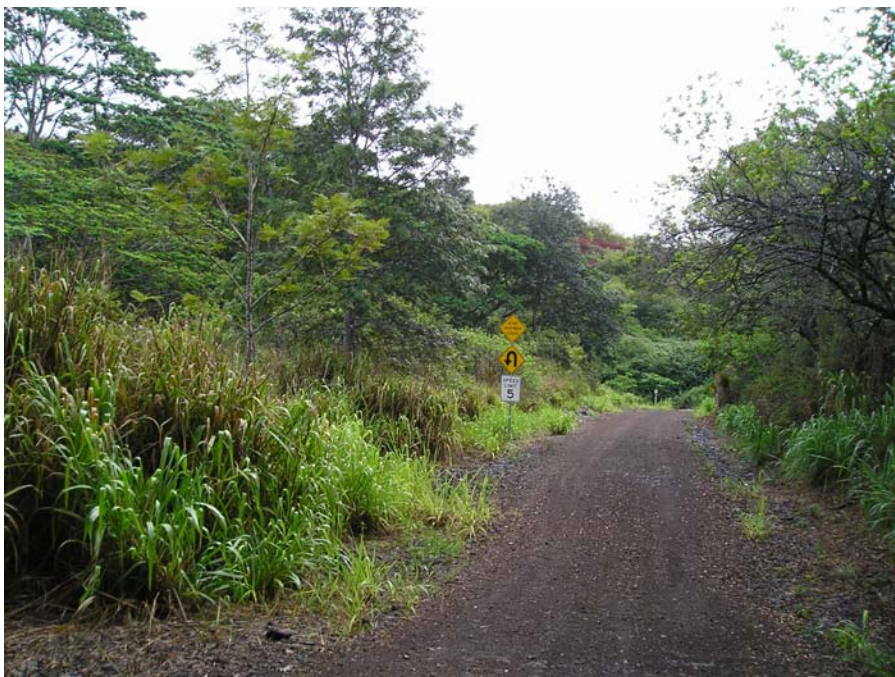
Project No. 17012-012185.00	Description	Unpaved road extending down into Poamoho Gulch at north-central boundary of subject property (Parcel 3), looking east	Photo 17
	Site Name	Galbraith Estate Property, Wahiawa, Oahu, Hawaii	Photo Date October 16, 2012
	Client	Trust for Public Land

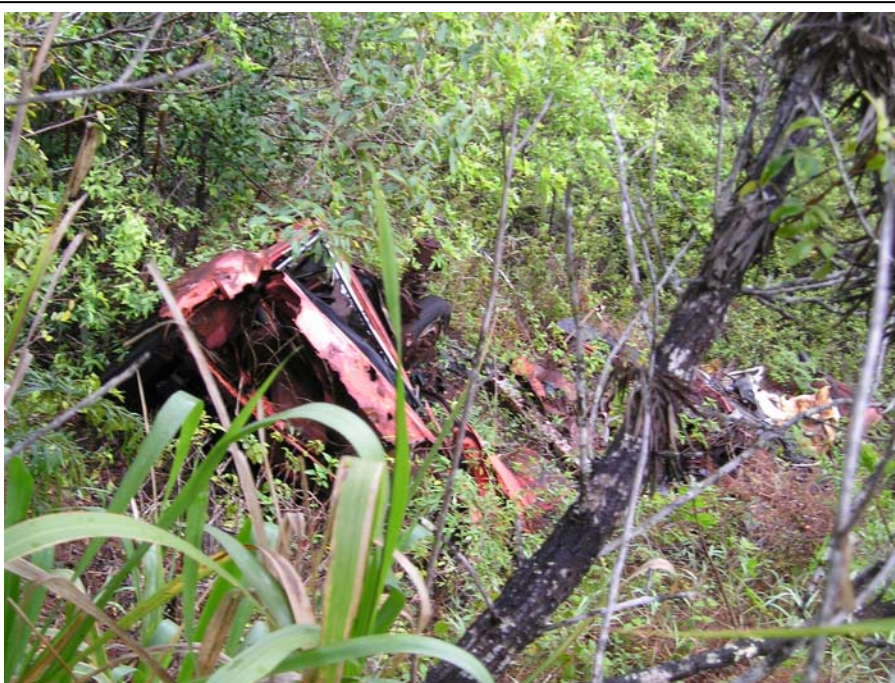
Project No. 17012-012185.00	Description	Two wrecked cars and car parts on embankment along winding dirt road that extends down into Poamoho Gulch (21 31' 15.1" N/158 2' 55.2" W)	Photo 18
	Site Name	Galbraith Estate Property, Wahiawa, Oahu, Hawaii	Photo Date October 16, 2012
	Client	Trust for Public Land

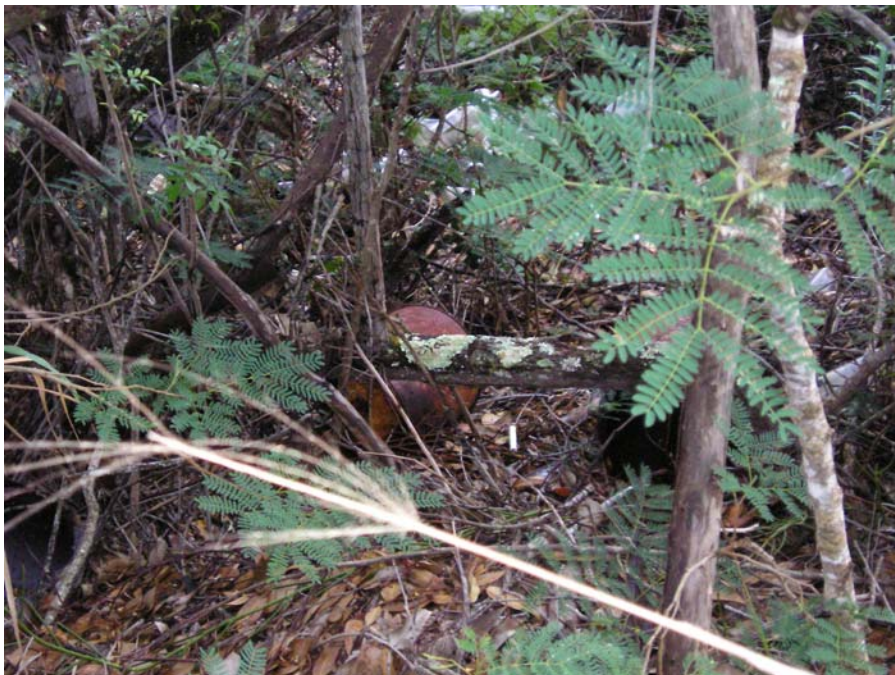
Project No. 17012-012185.00	Description	55-gallon drum and garbage cans on embankment along winding dirt road that extends into Poamoho Gulch (21 31' 15.5" N/158 2' 57.0" W)	Photo 19
	Site Name	Galbraith Estate Property, Wahiawa, Oahu, Hawaii	Photo Date October 16, 2012
	Client	Trust for Public Land

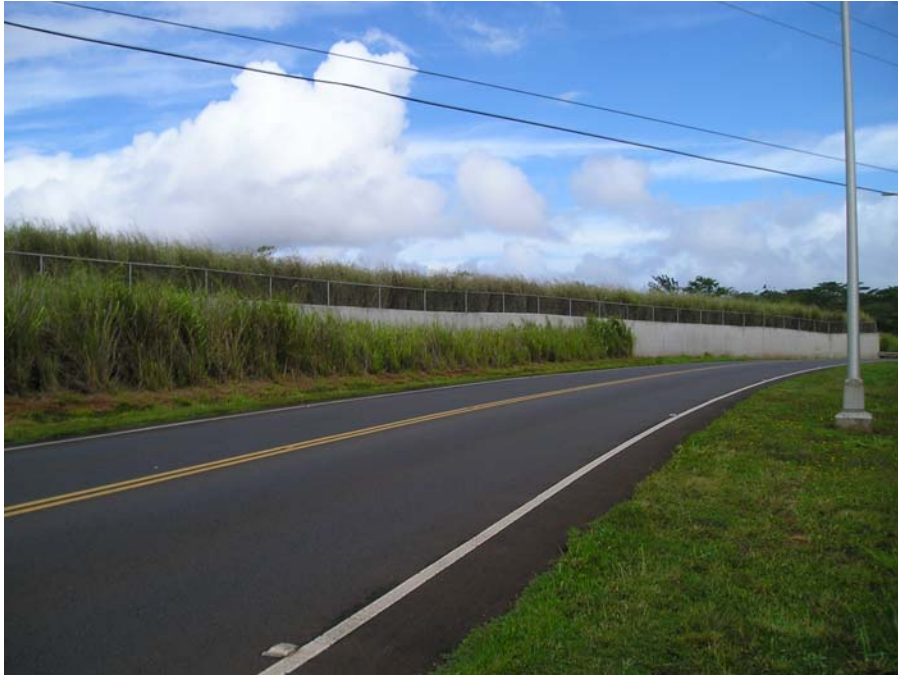
- During one of Bureau Veritas' previous Phase I assessments, conducted in April of 2008, a new road for the United States Navy was under construction along the northeastern boundary, and extending through the northeast corner of the subject property. Initial construction of a bridge was underway at the nearby Poamoho Stream Gulch, and a road cutaway had been excavated for installation of the bridge. Small pieces of garbage were observed mixed in with the soil of the road cutaway along the edge of the subject property. According to personnel with the onsite construction contractor, Dick Pacific Construction Company, Ltd., a significant amount of garbage and debris were encountered during the excavation, including household-type garbage, wrecked cars, and car parts. Although the Navy roadway bridge is not part of the subject property, this discovery indicates the potential for additional garbage, cars, and car parts to be buried along the edges of the subject property immediately adjacent to the area excavated by the Navy.

Project No. 17012-012185.00	Description	Navy road near northeast edge of subject property, where buried garbage, cars, and car parts were discovered during construction	Photo 23
	Site Name	Galbraith Estate Property, Wahiawa, Oahu, Hawaii	Photo Date October 16, 2012
	Client	Trust for Public Land

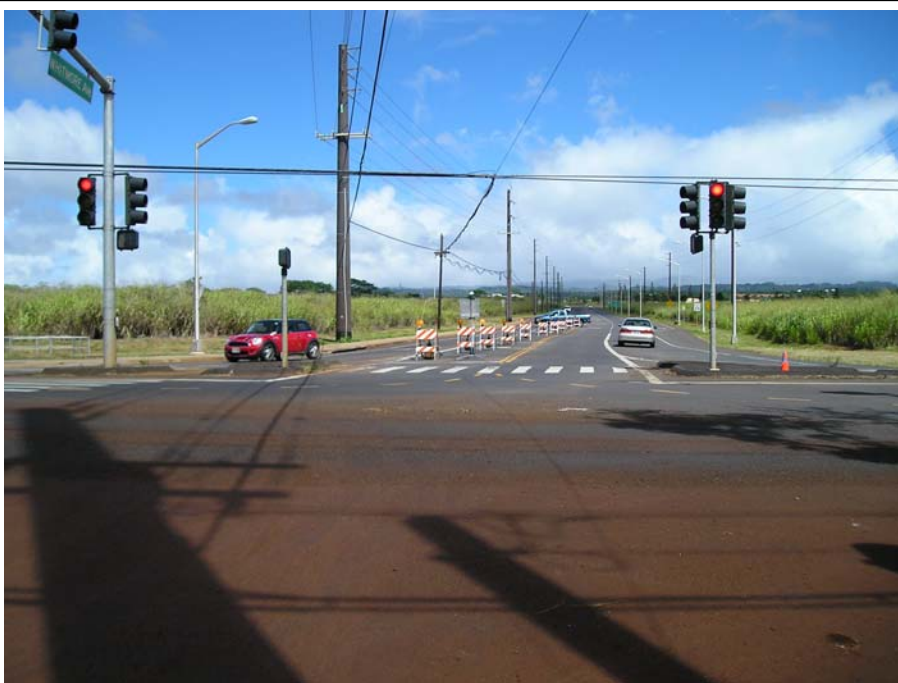
Project No. 17012-012185.00	Description	View of Whitmore Avenue along eastern edge of subject property (Parcel 28), looking northeast	Photo 24
	Site Name	Galbraith Estate Property, Wahiawa, Oahu, Hawaii	Photo Date October 16, 2012
	Client	Trust for Public Land

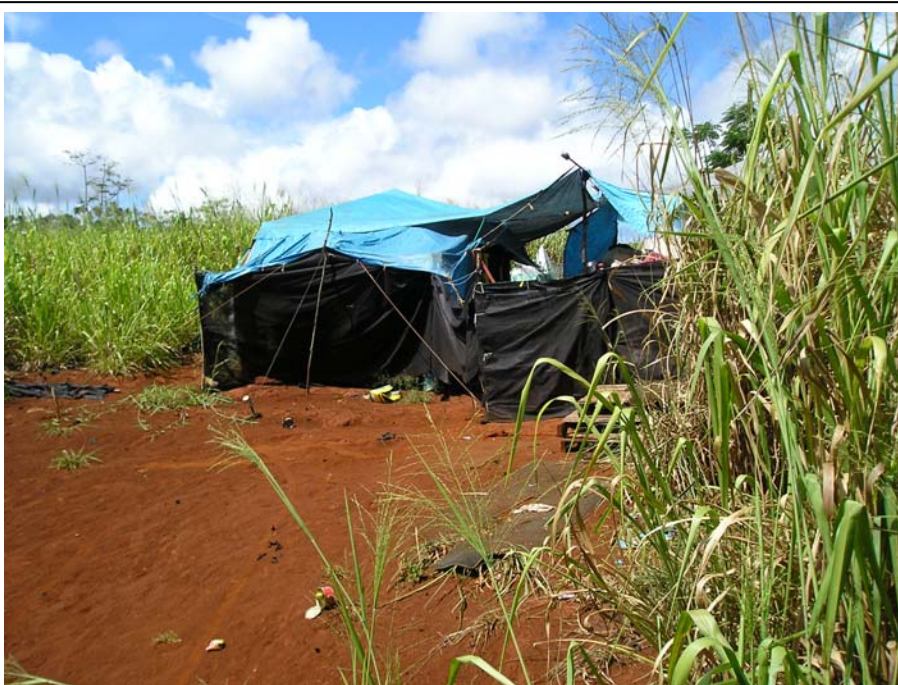
Project No. 17012-012185.00	Description	Squatters' camp on eastern portion of subject property (Parcel 8), accessible from foot trail along eastern edge of subject property	Photo 26
	Site Name	Galbraith Estate Property, Wahiawa, Oahu, Hawaii	Photo Date October 16, 2012
	Client	Trust for Public Land

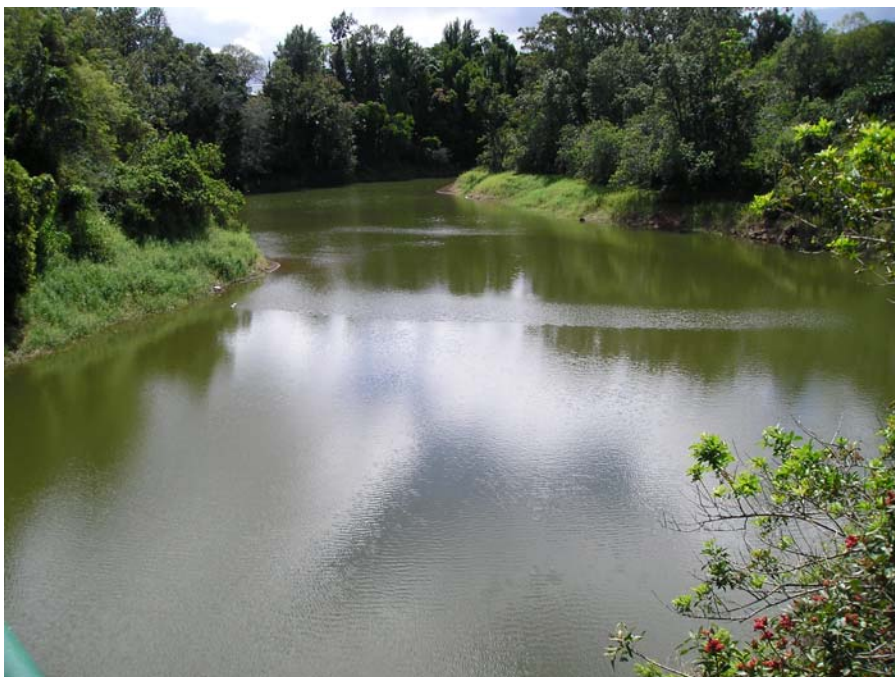
Project No. 17012-012185.00	Description	Kaukonahua Stream adjacent to east side of subject property, looking south	Photo 27
	Site Name	Galbraith Estate Property, Wahiawa, Oahu, Hawaii	Photo Date October 16, 2012
	Client	Trust for Public Land

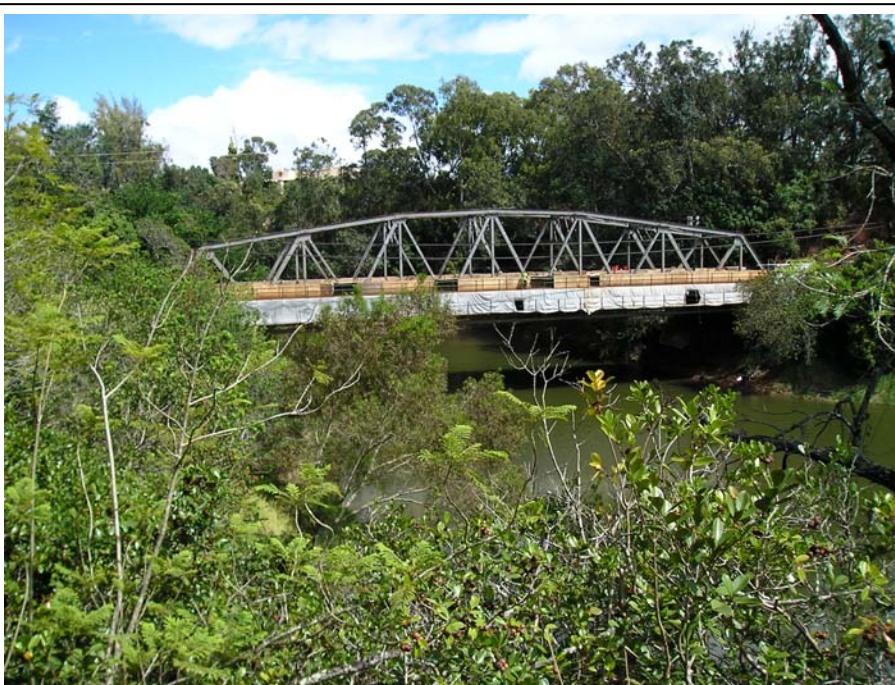
Project No. 17012-012185.00	Description	Kamehameha Highway at Karston Bridge (over Kaukonahua Stream), located east of subject property, looking northeast	Photo 28
	Site Name	Galbraith Estate Property, Wahiawa, Oahu, Hawaii	Photo Date October 16, 2012
	Client	Trust for Public Land
